### **Many Plant Configurations That EAI Terms "Violations" Are Not**

### **Entergy Is Not Complying With Its Own Standards**

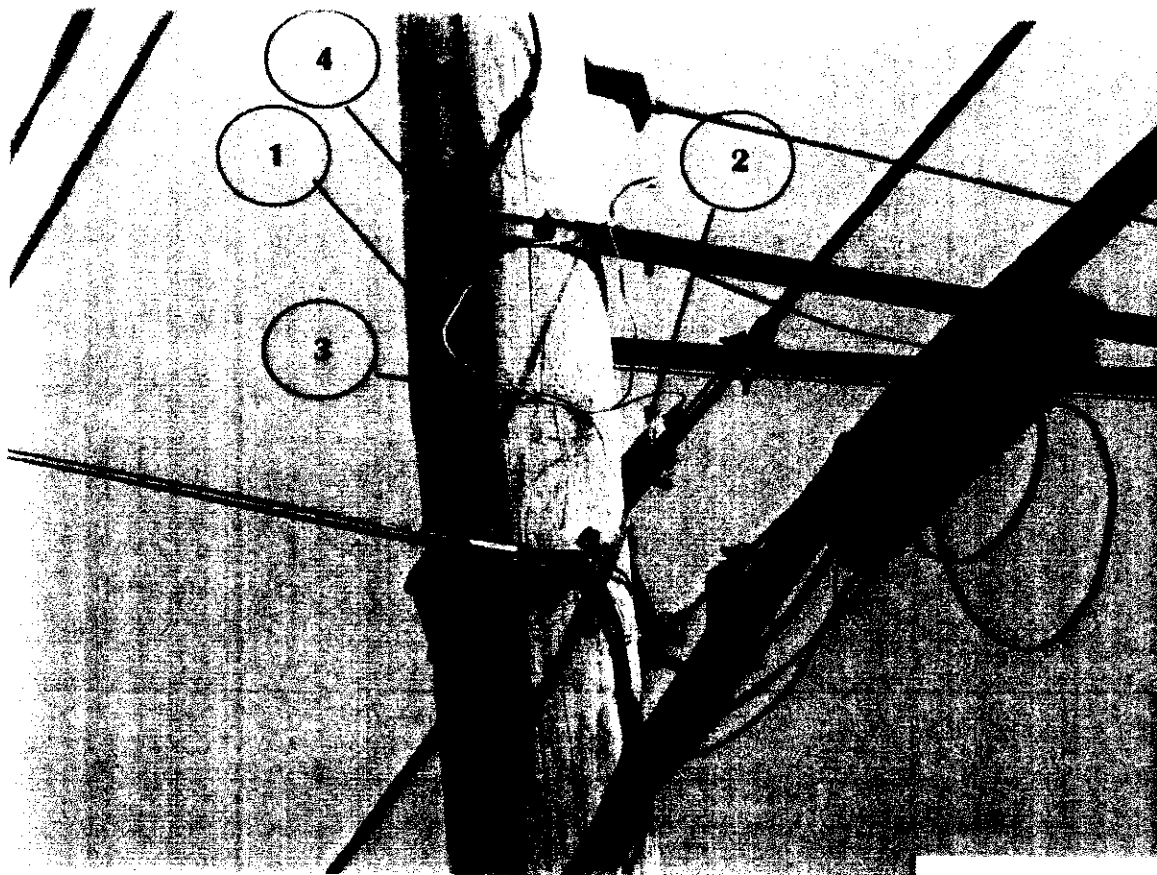
- 41A -

This photo, which I took, shows a street light which EAI could readily have installed in compliance with the NESC but the white lead from the light (Arrow #1) runs down the pole until it almost touches the cable tv attachment (Arrow #2) and does touch the cable bond wire (Arrow #3). Then this white street light lead goes back up and connects to the EAI pole ground wire (Arrow #4). EAI has created three violations here. First, street light leads must be 12" above CATV. Second, the white neutral lead must connect to a neutral conductor (wire) not a pole ground wire. Third, the street light bracket must be grounded, or, the bracket must be 20 inches from cable. EAI's contractor, USS, which inspected this pole has seldom noted a street light grounding violation and never noted an incorrectly connected neutral. These numerous violations of the basic provisions of the NESC create real hazards to communications workers and electric workers alike and are the responsibility of the electric company to correct. Jacksonville, AR. N. First St.

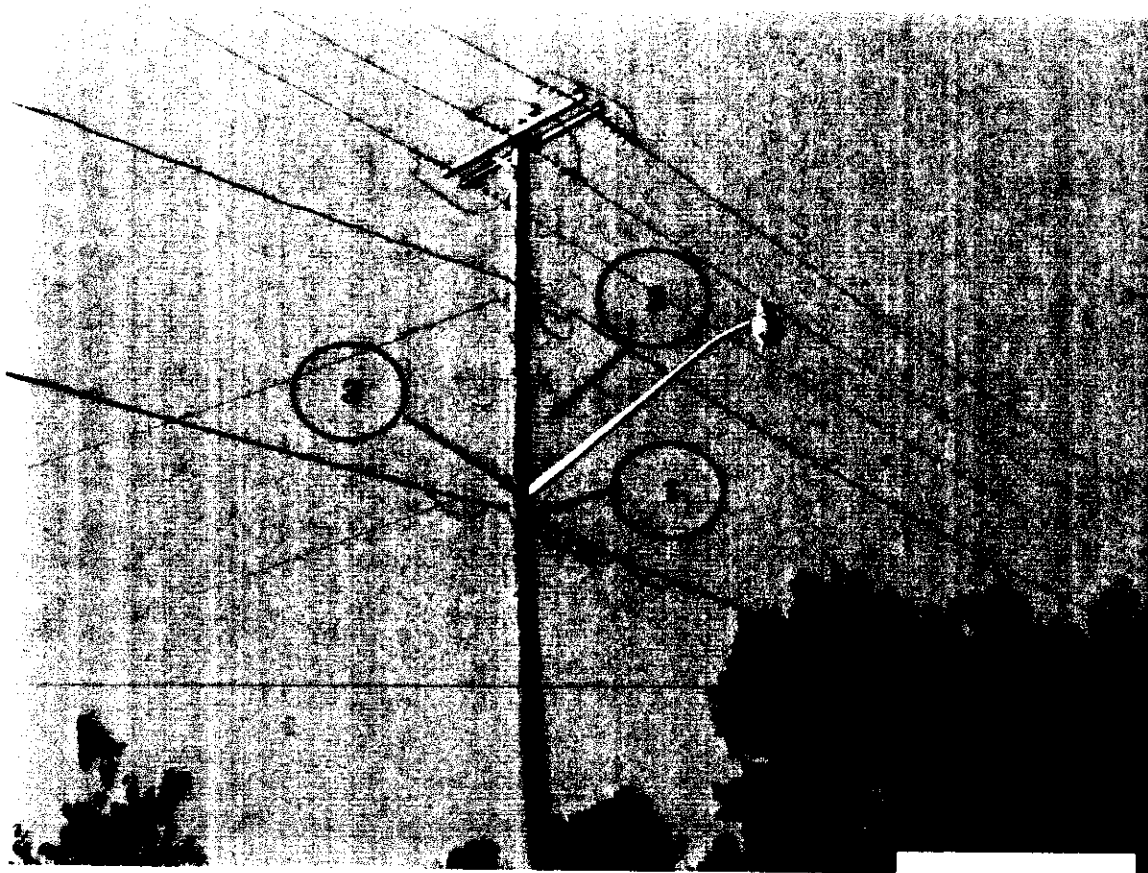
- 42A -

This photo which I took, shows a street light placed much too close to cable (Arrow #1). One hot wire lead (120 v.) hangs down alongside the pole (Arrow #2). The neutral wire for the light is connected to the pole ground at the same level as the cable television attachment. The bracket is not grounded (Arrow #3). There are four significant EAI violations at this location: (1) the street light leads are less than 12 inches to cable; (2) the bracket is grounded and is less than 20 inches to cable; (3) the neutral is connected to pole ground; (4) the long, hot wire is not secured to the pole. Location: Little Rock Mablevale Pike.

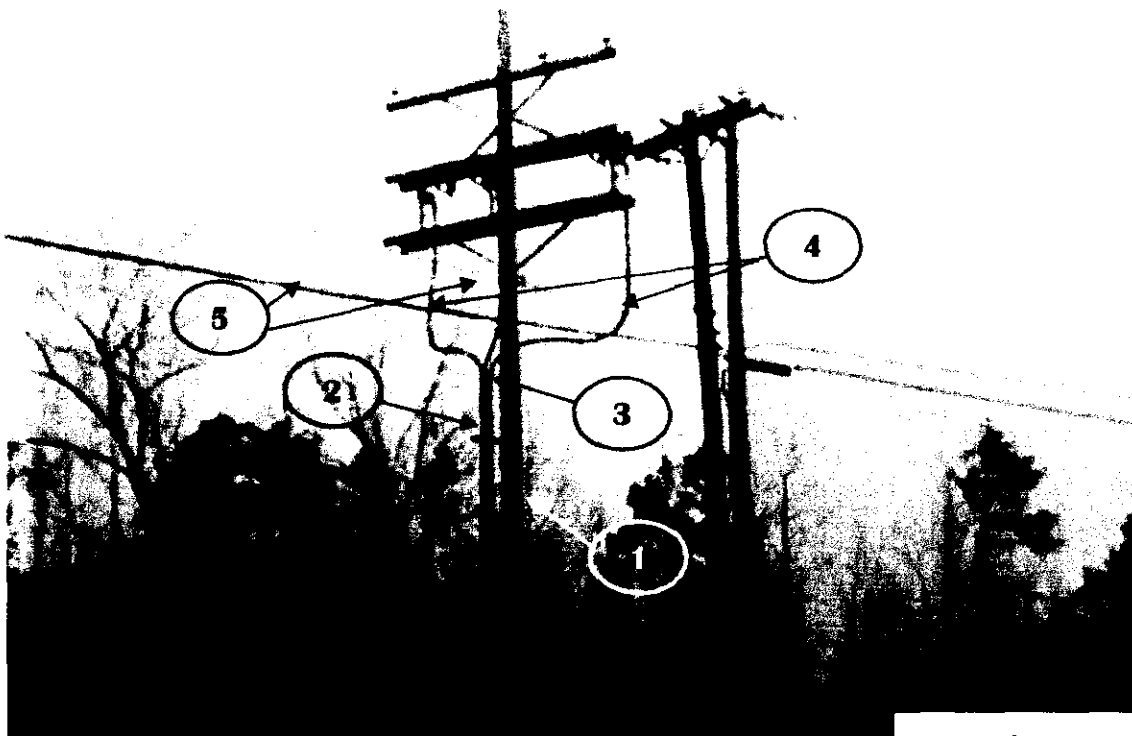
- 49A -

This new pole (Arrow #1) and high voltage primary cable riser (Arrow #2) was installed by EAI. The riser pipe (Arrow #3) stopped below cable (Arrow #4), not 40 inches above as EAI insists is their mandatory standard. The electric cable then flared out from the riser, completely surrounding the cable TV facility (Arrow #4). Comcast ultimately was able to extricate its facilities, but only by cutting them down – a very expensive and wasteful operation that could have been avoided if EAI had sought to notify attachers of this new installation and coordinate the project. This photo was taken at the direction of Marc Billingsley of Comcast.

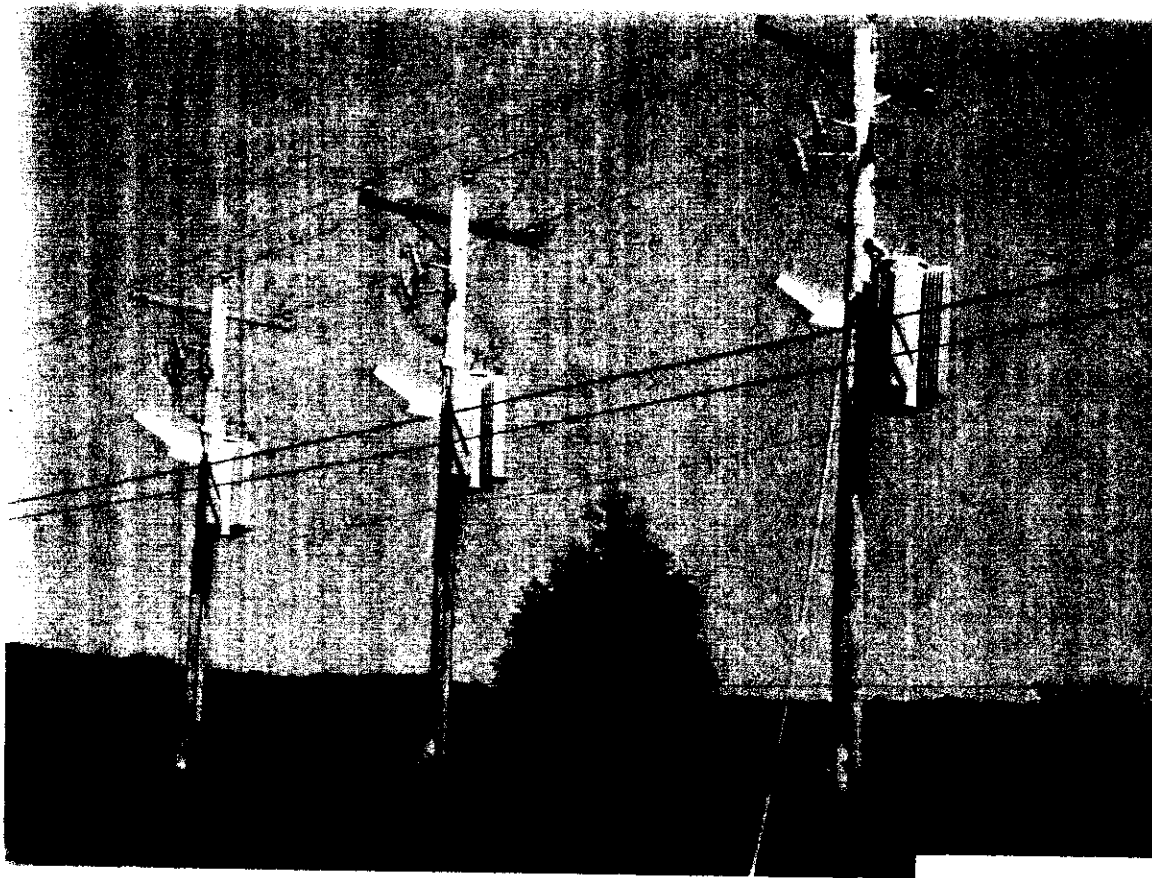
- 50A -

These photographs were taken at the direction of Jeff Gould of Cox in that company's Russelville system. Here, the power company very recently has (1) installed new poles; (2) put up three step voltage regulators, and (3) put the regulator tanks into direct contact with the pre-existing communications lines. The communications cable near the top of the long regulator tanks is much less than 40 inches to the exposed high-voltage wires and connections on top of the regulator tanks and within easy reach of workers and sudden death. In addition, the neutral that according to EAI must in all cases be 40 inches *above* communications, EAI actually installed several feet *below* communications. But the communications lines are not connected to these poles and are merely rubbing against these regulator tanks. This is obvious from the next photo.

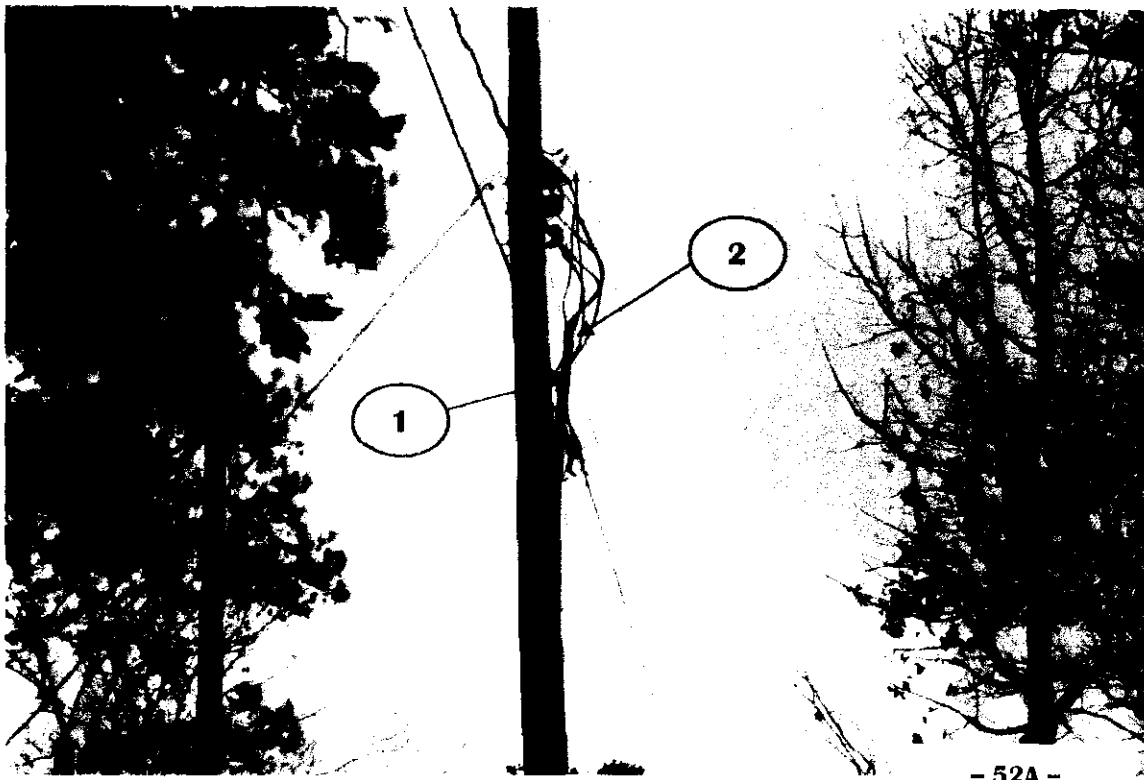
- 52A -

This photo depicts a typical EAI configuration in Arkansas. Not only has the power company installed the electric riser and conduit literally on top of the cable television facilities (Arrow #1), but the riser is too short (Arrow #2), creating multiple violations of the electric-to-communications clearance standards of the NESC. Note also the "fly-away" appearance of the riser conduit. These electric cables above the riser pipes, which pin cable television poles and preventing CATV workers from accessing facilities without touching power, should be corrected immediately by EAI. This photo was taken at the direction of Marc Billingsley of Comcast.

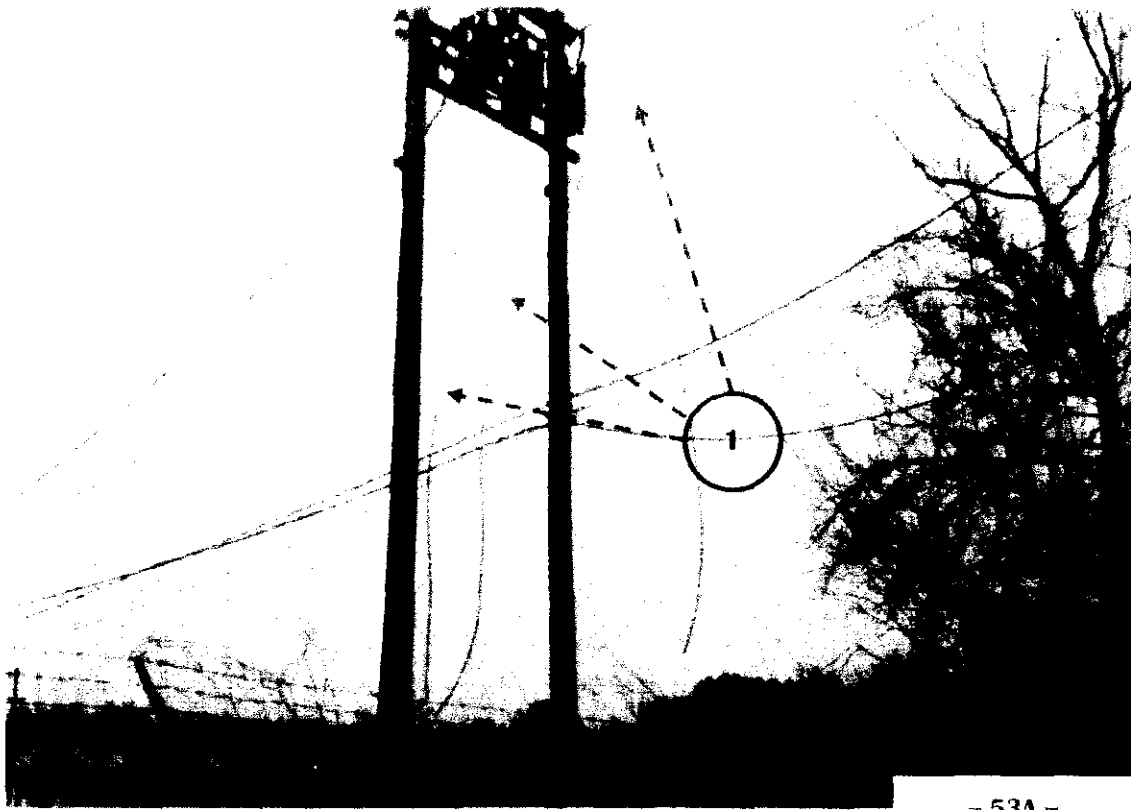
- 53A -

This photograph which was taken at the direction of Marc Billingsley of Comcast, shows dead primary lines hanging down (Arrow #1) from the top of high-voltage power distribution poles near an abandoned bicycle factory at 6301 Patterson Road in Little Rock. The power lines, even though apparently de-activated, create a dangerous situation because they touch the cable television support strand and they hang down low to the ground. The work rules of the NESC apply to electric workers and communications workers. They do not permit workers to treat such lines as dead unless they are disconnected from the source, tested for absence of voltage and grounded. Further, NESC rule 214.B.3. states that lines permanently abandoned shall be removed or maintained in a safe condition. These abandoned lines create serious hazards for workers and the public.

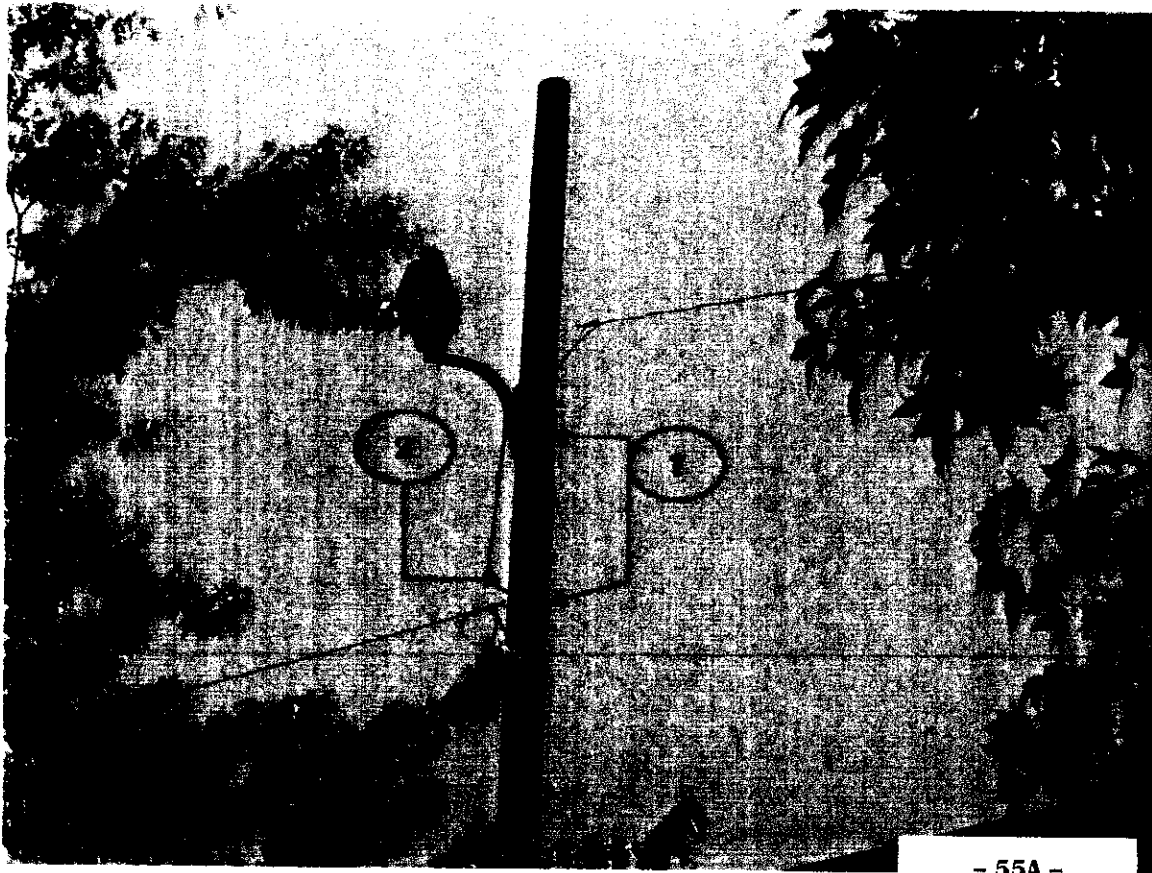
- 55A -

This new street light illuminates the parking lot at the Comcast building in Little Rock. There is ample separation between the light bracket and the communications drop (Arrow #1) but EAI has built this new light with excessively long power leads (Arrow #2), hanging down closer than 12 inches above communications. Location: Little Rock, Enmar Dr

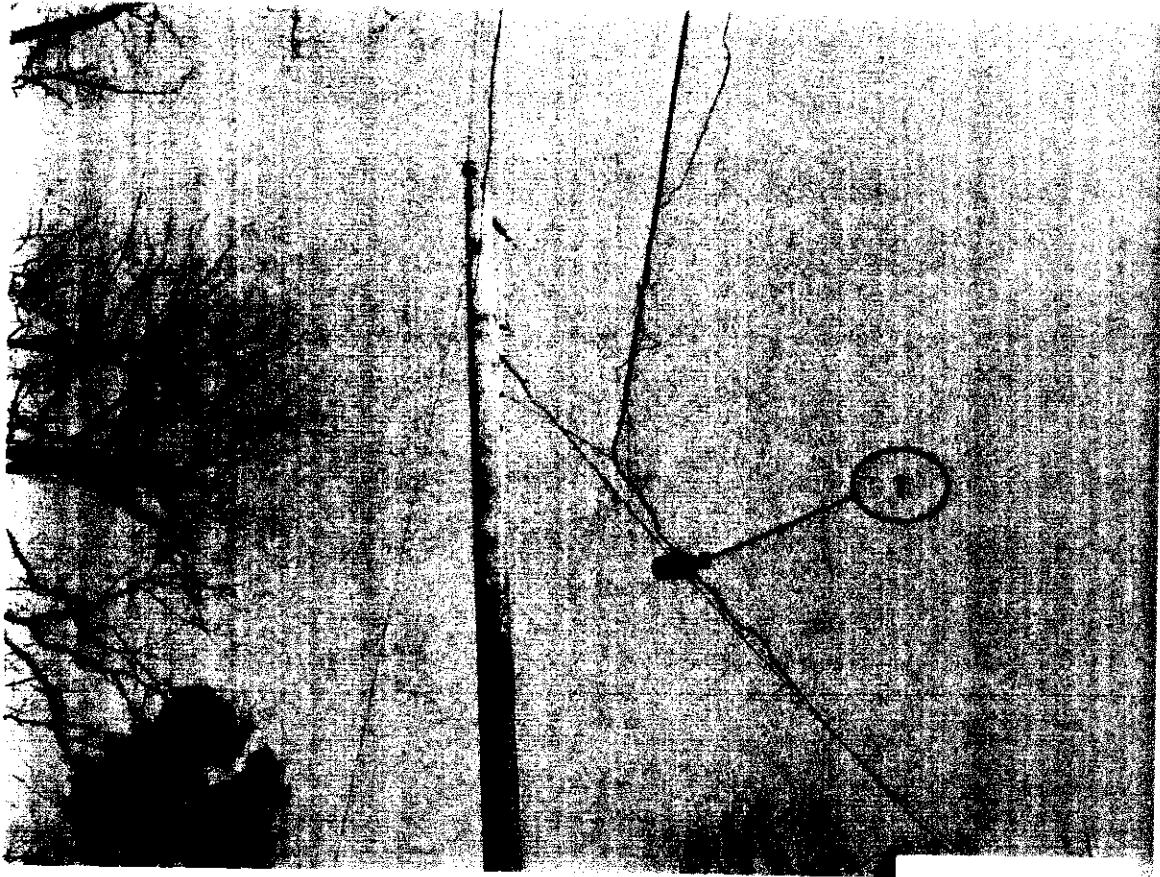
- 57A -

This photo, which I took, shows another EAI pole that apparently was broken by a vehicle. EAI tied Comcast's cable, plus a big chunk of the pole that it had sawed off from the old pole with a piece of scrap wire (Arrow #1). Comcast discovered this during a make-ready ride-out to assist another party in gaining access to Entergy poles in March 2005. This is a good example, and there are countless other ones, where EAI simply did not inform cable that it had performed work on the cable tv facilities. This continues to be a big problem. Location: Jacksonville Hwy 67/267.

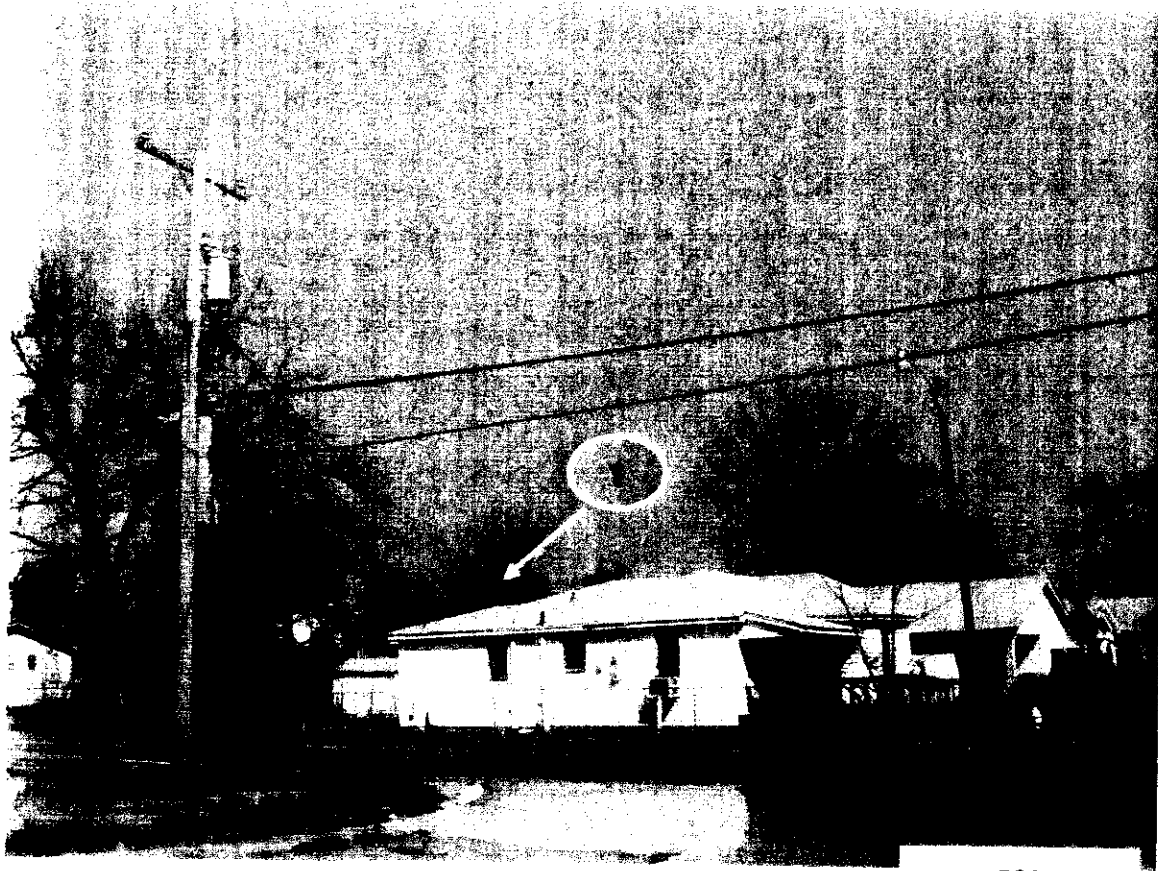
- 58A -

This photo, which I took, shows a very low electric service that is only 12 feet above the street (Arrow #1). NESC Rule 232 Table 232-1 requires it to be 16 feet. Unless it is raised, eventually a tall vehicle will pull this hot electric wire down. Location: Little Rock E 11<sup>th</sup> St and J.L. Hawkins St.

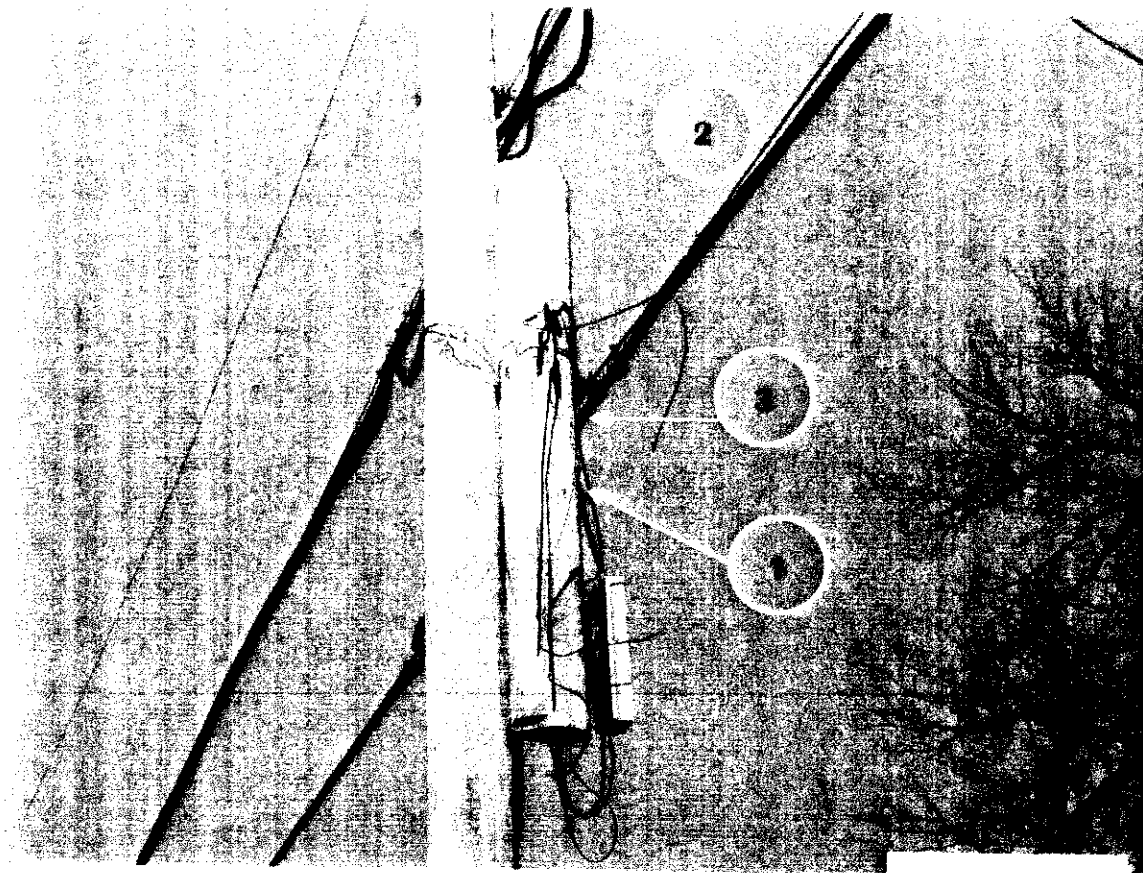
- 59A -

This pole, which is the same one as the prior photo shows a 5-foot length of the old broken pole, wired to the new pole by EAI (Arrow #1). You can see that the cable company has transferred its facility (Arrow #2) from the old pole to the new pole, but that the telephone company (Arrow #3) has not. Comcast notified EAI of this hazard, which EAI most likely created in conducting an emergency repair to the pole after a vehicle collision. Location: Little Rock E. 11<sup>th</sup> St and J.L. Hawkins St.
